SSCA Discussion on the Icom M-802 Clipping Issue

Re: Icom M-802 "Clipping Issue" - Revisited....

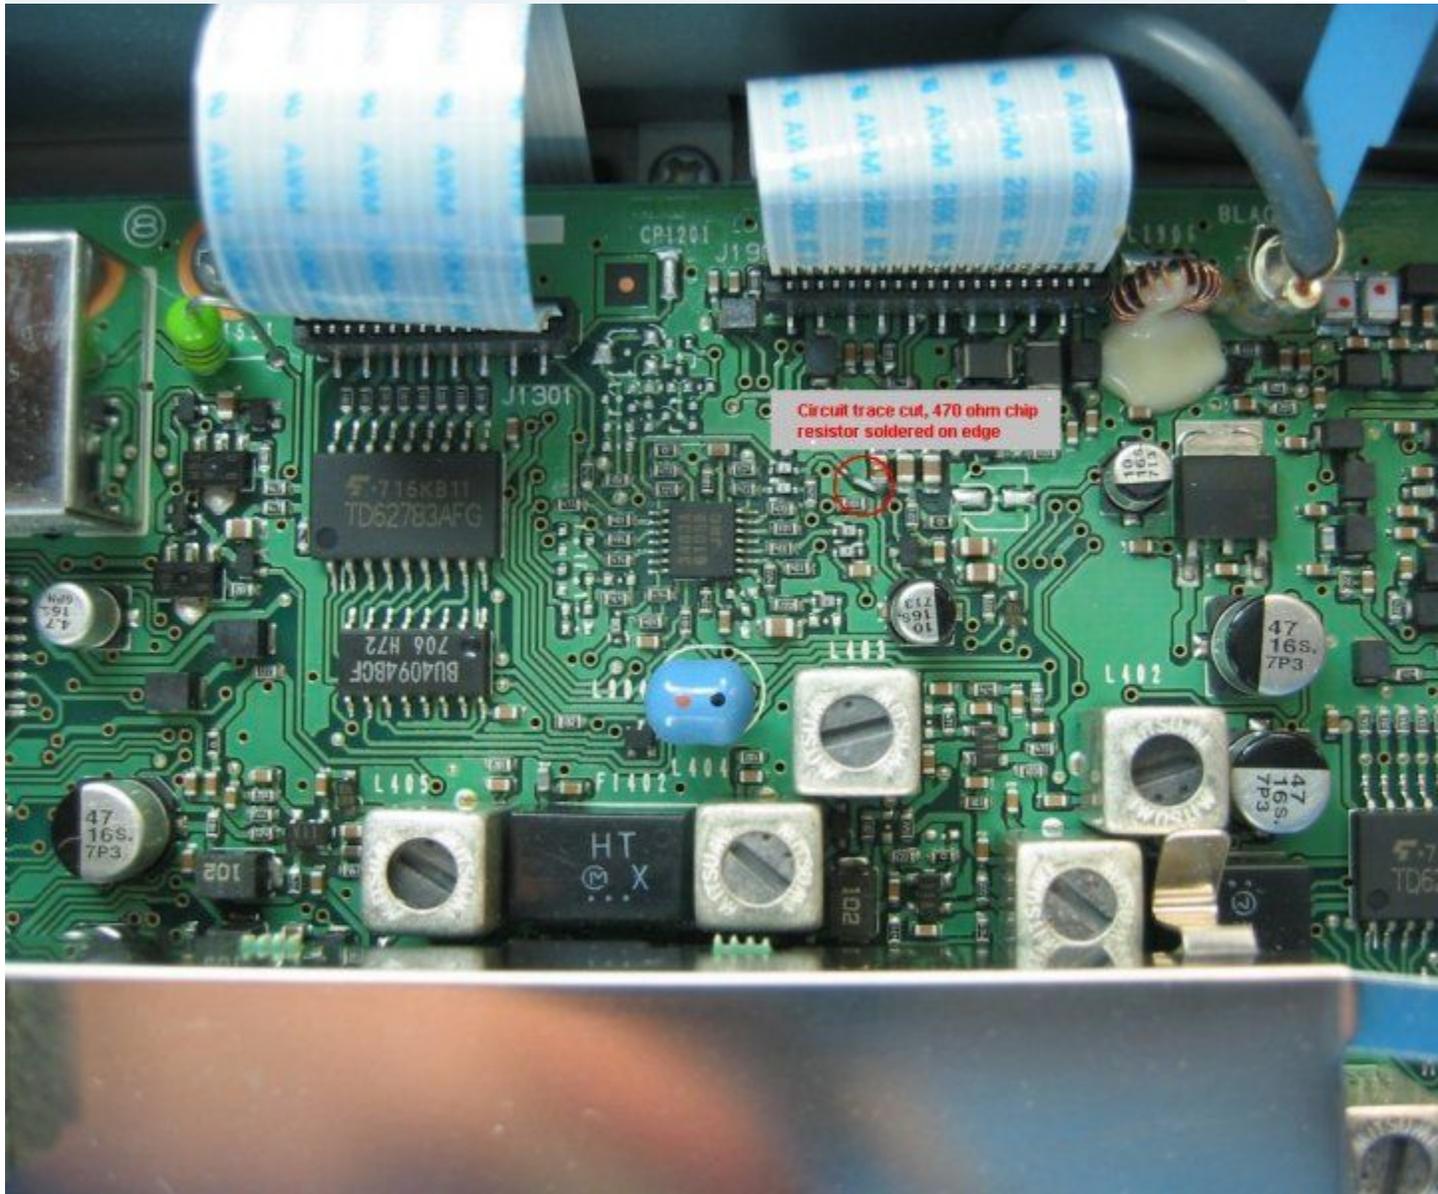
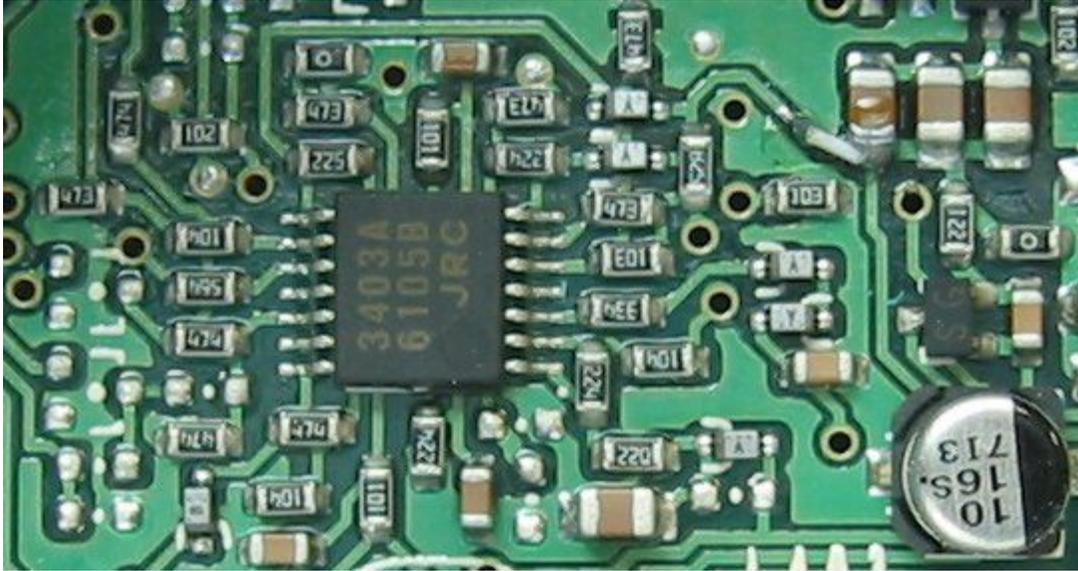
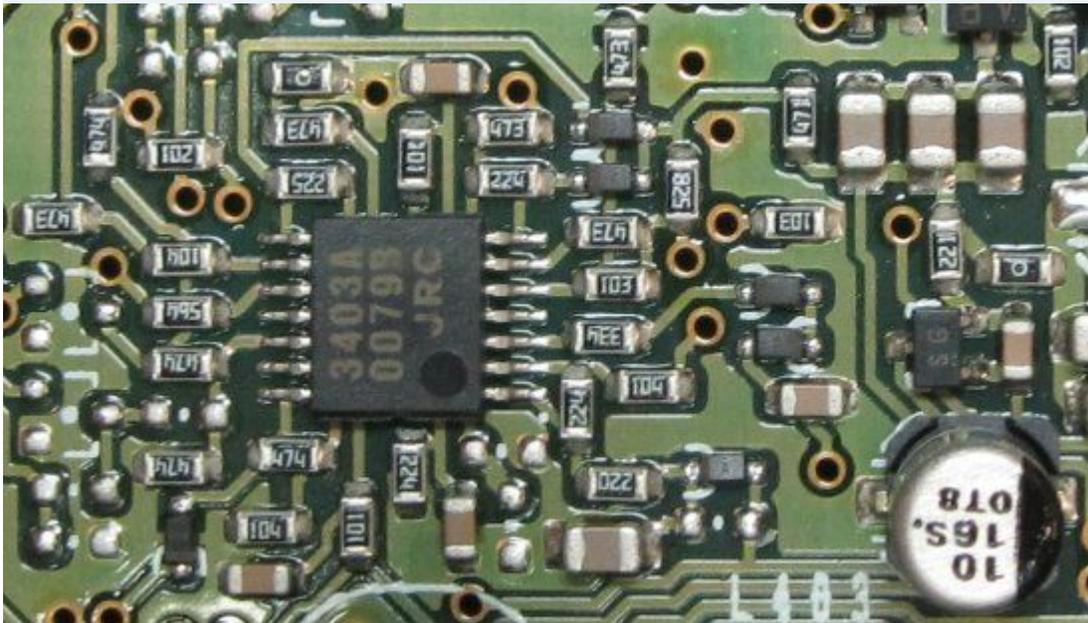
If you have a transceiver with serial number before 0108261, you can visually check for the mod by removing the cover of the transceiver and look for the added resistor near the center back edge of the main board which is the large board you see after removing the top cover. To add the resistor, a circuit trace is cut and the chip resistor is soldered on edge bridging the cut. Icom has now come out with a new board version that accommodates the resistor placement. See photo's. If you're a good techie with magnifiers, the right soldering tools and steady hands, you can easily do it yourself. I've done a few.
