## DIESEL ENGINES

The challenges of getting engine work done while voyaging

# Diesel Overhaul in the Kai Islands

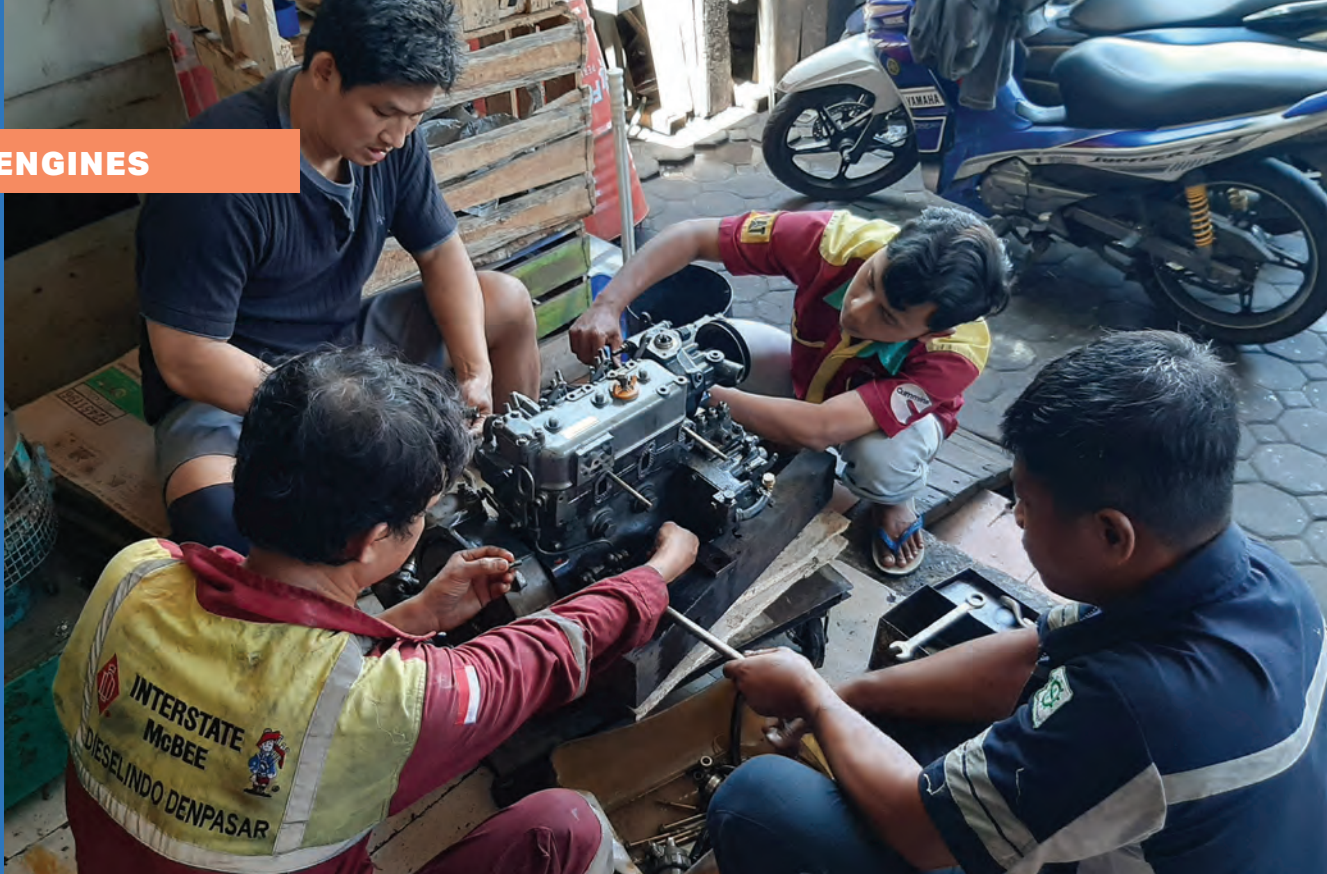
Above, a crew of Indonesian mechanics works on one of the McCampbell's diesels. Right, the McCampbell's St. Francis 44 cat, *Soggy Paws*.

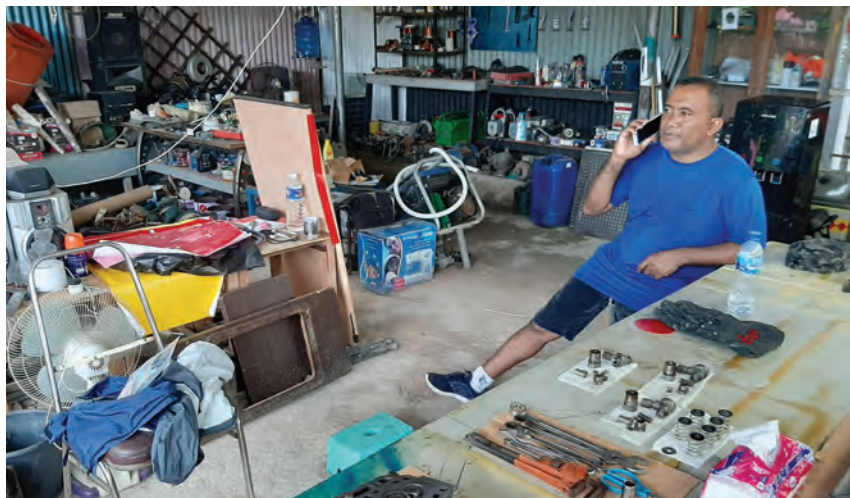
**Above, Tual mechanic John in his workshop**  
**Left, John's crew carrying the engine down the Coast Guard dock.**

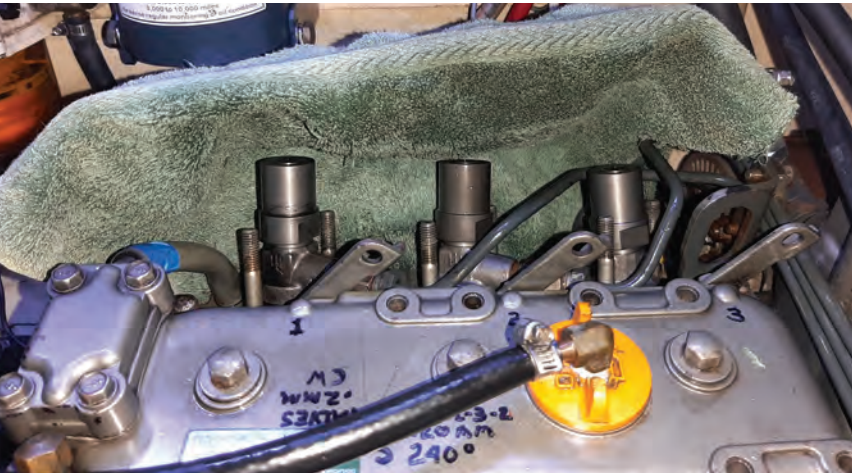
After stopping the engine and some discussion, he took the three injectors out and reconnected them upside down so they would spray up instead of down into the cylinders. We held a towel above them and then engaged the starter. Diesel spray went up into the towel from each injector in turn. We could clearly see that one injector was squirting rather than spraying fuel, and they were all leaking. Also, an assortment of parts came flying out of the injector holes. After finally collecting all the parts, we decided to regroup, clean things up, do a proper cleaning and pop test for the injectors, and make one new heat shield and new copper covers in case

**Injectors set up upside down to test for proper function.**

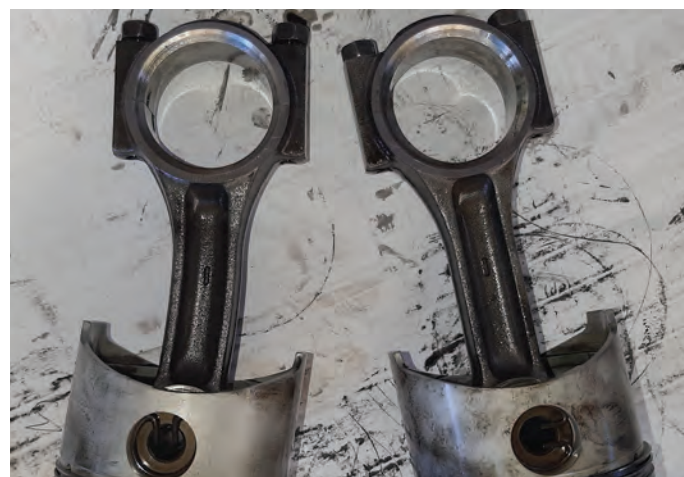
Again we found multiple problems: a bent rod, damaged probably during a cylinder hydro lock event from the leaking cylinder head gasket, one piston rod that was shorter than a new rod by about 2 mil-

Once removed from the engine the piston on the left was discovered to have a bent rod.

limeters, leaking valve seats and seals, worn rings, leaking lip seals, worn shell bearings, and a cracked piston. After additional inspection we decided that since the engine was fully apart now we should replace all the normal wear parts including gaskets, O-rings, shell and roller bearings, piston rings, valve and other seals, most water and fuel hoses, injector covers and fuel and air filters.

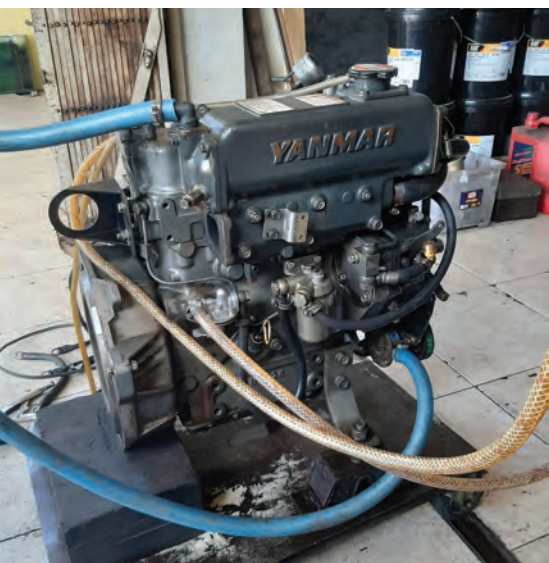
The second engine unpainted and ready for testing at mechanic Hasta's shop.

Only a week later I was present for the engine bench test at his shop. There had been no major issues other than wear which required replacement parts similar to the starboard engine. Again the injection pump timing test was right on with just the original shims, and there were no significant problems. I also had Hasta add mechanical oil pressure gauges at the engines and recheck all injectors for proper spray and pressure. The engine came back aboard spotlessly clean and freshly painted. This time I let Hasta and his mechanics do the
